Aesthetic Restoration of an Anterior Incisor: Post and Core Management - A Case Report

Introduction: Rehabilitation of endodontically treated anterior teeth presents a clinical challenge that requires a careful balance between esthetics, function, and biomechanical stability. This case report describes a conservative, prosthetically driven approach using a prefabricated fiber post and a zirconia crown for the restoration of a fractured maxillary lateral incisor.

Case Presentation: A 34-year-old female patient presented with a traumatically fractured maxillary lateral incisor (22). Following endodontic therapy, a prefabricated fiber-reinforced post was cemented with dual-cure resin cement, followed by composite core build-up and restoration with a translucent zirconia crown. The treatment successfully restored tooth form, function, and esthetics with satisfactory shade matching and patient acceptance.

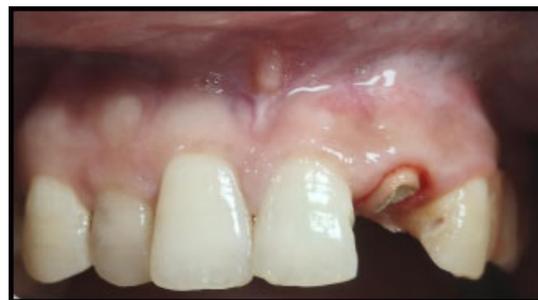
Fig. (1). PRE-operative.

Santosh Dental College and Hospital, Ghaziabad, following a traumatic fall. Her chief complaint was a fractured maxillary anterior tooth accompanied by compromised facial esthetics. The patient had no previous restorative or endodontic treatment on the affected tooth and maintained satisfactory oral hygiene. Clinical examination revealed no evidence of pain, swelling, or associated soft-tissue pathology. Intraoral evaluation identified an Ellis Class III fracture involving the maxillary left lateral incisor (tooth 22), as illustrated in Fig. (1). Radiographic assessment revealed loss of tooth structure involving the enamel and dentin with pulpal involvement. Pulp vitality testing further confirmed that the tooth was non-vital. The traumatic incident was isolated, and this clinical context guided our decision to use a conservative, adhesive fiber post-and-core system to preserve residual tooth structure.

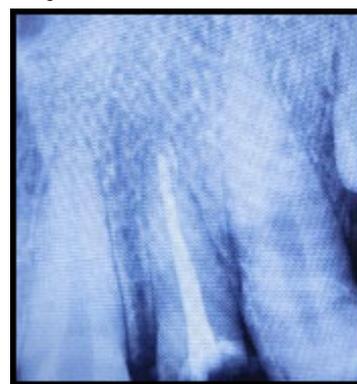
Fig. (2). PRE-operative radiograph.

It was recommended that the patient undergo root canal therapy, a post and core build-up, and finally a final crown restoration. After administering local anesthesia, an endodontic access cavity was created, the canal orifices were identified, and the working length was established. The canal was biomechanically prepared up to size 25 with a 0.06 taper, followed by obturation using the single-cone technique in conjunction with AH Plus sealer (Fig. 2).

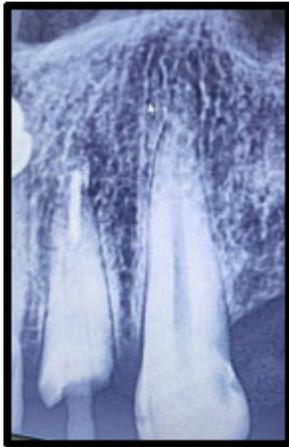
Fig. (3). Post space preparation.

Peeso reamers (sizes 1 and 2) were used for post-space preparation, making sure that 3-4 mm of gutta-percha was retained at the apex. Next, a dual-cure resin cement was used to lute a prefabricated fiber-reinforced post into the

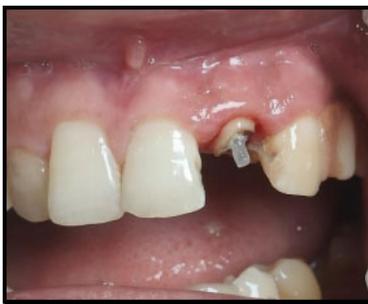
Fig. (4). Fiber post in position.

canal (Fig. 3). Once the fiber post was in position (Fig. 4). Composite resin was then used to build up the core (Fig. 5). Occlusal view of the core build-up is shown in Fig. (6). Finally, a highly translucent all-ceramic crown was placed, restoring the tooth's function and aesthetics in alignment with the surrounding dentition in occlusion (Fig. 7) and Occlusal view (Fig. 8).
